DEVELOPMENT, TESTING AND EVALUATION OF MHD-MATERIALS

Quarterly Report

for the period Jan. - March, 1976

Inorganic Materials Division
Institute for Materials Research
National Bureau of Standards
Washington, D. C. 20234

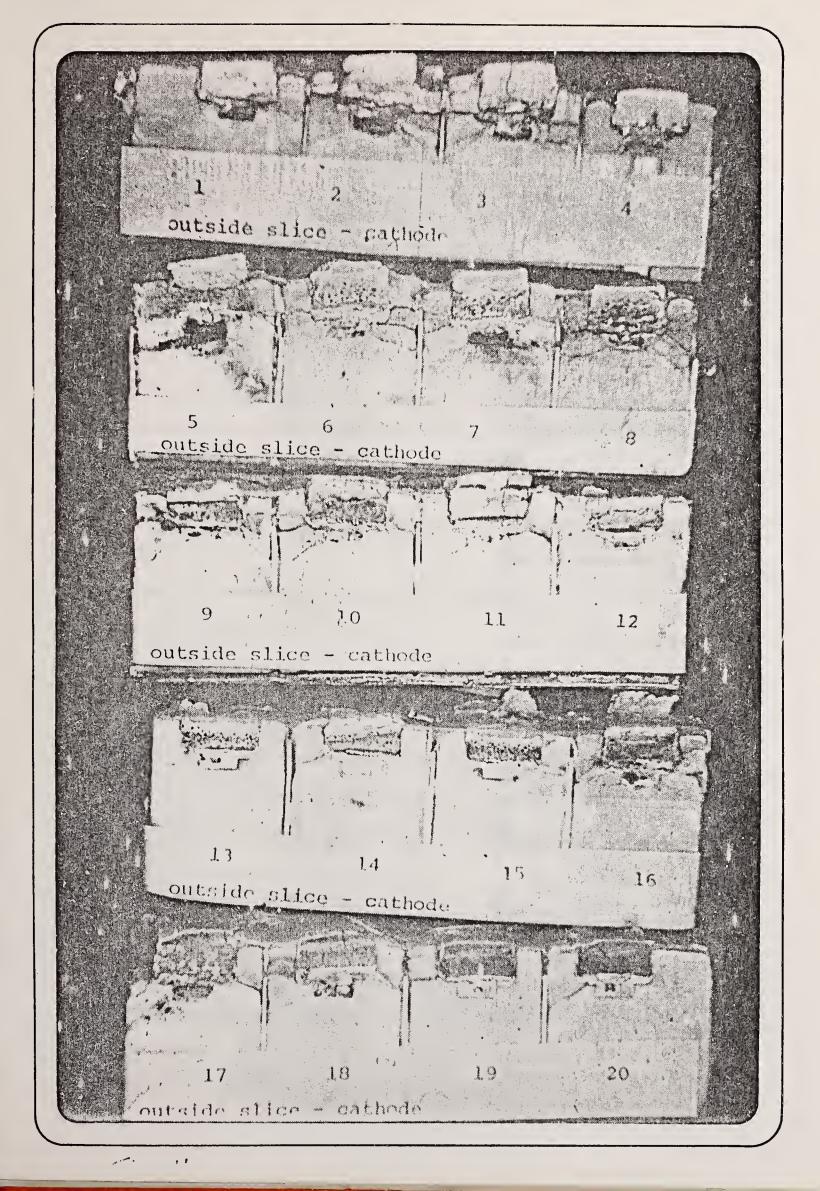
As discussed in the previous Quarterly Report (December 31, 1975) several slices of each of the 5 sub-modules were obtained by sawing lengthwise through the electrode assembly. Figures la and lb show a photograph of cathode and anode cross sections of each of the 5 sub-modules. The numbers correspond to the last or last two digits of the 4-digit identification used for labeling the electrodes (See Fig. 2).

IDENTIFICATION DIGITS AND ELECTRODE LEAD-OUT FAILURE.

SHADED AREAS INDICATE WHICH LEAD FAILED (ANODE OR CATHODE).
